Chena River Lakes Project  
Fairbanks, Alaska

*Overview of Tanana River monitoring and  
research studies near Fairbanks, Alaska*

OVERVIEW OF TANANA RIVER MONITORING AND  
RESEARCH STUDIES NEAR FAIRBANKS, ALASKA  
(with Appendices)

Prepared by  
U.S. Army Cold Regions Research and Engineering Laboratory  
Hanover, New Hampshire

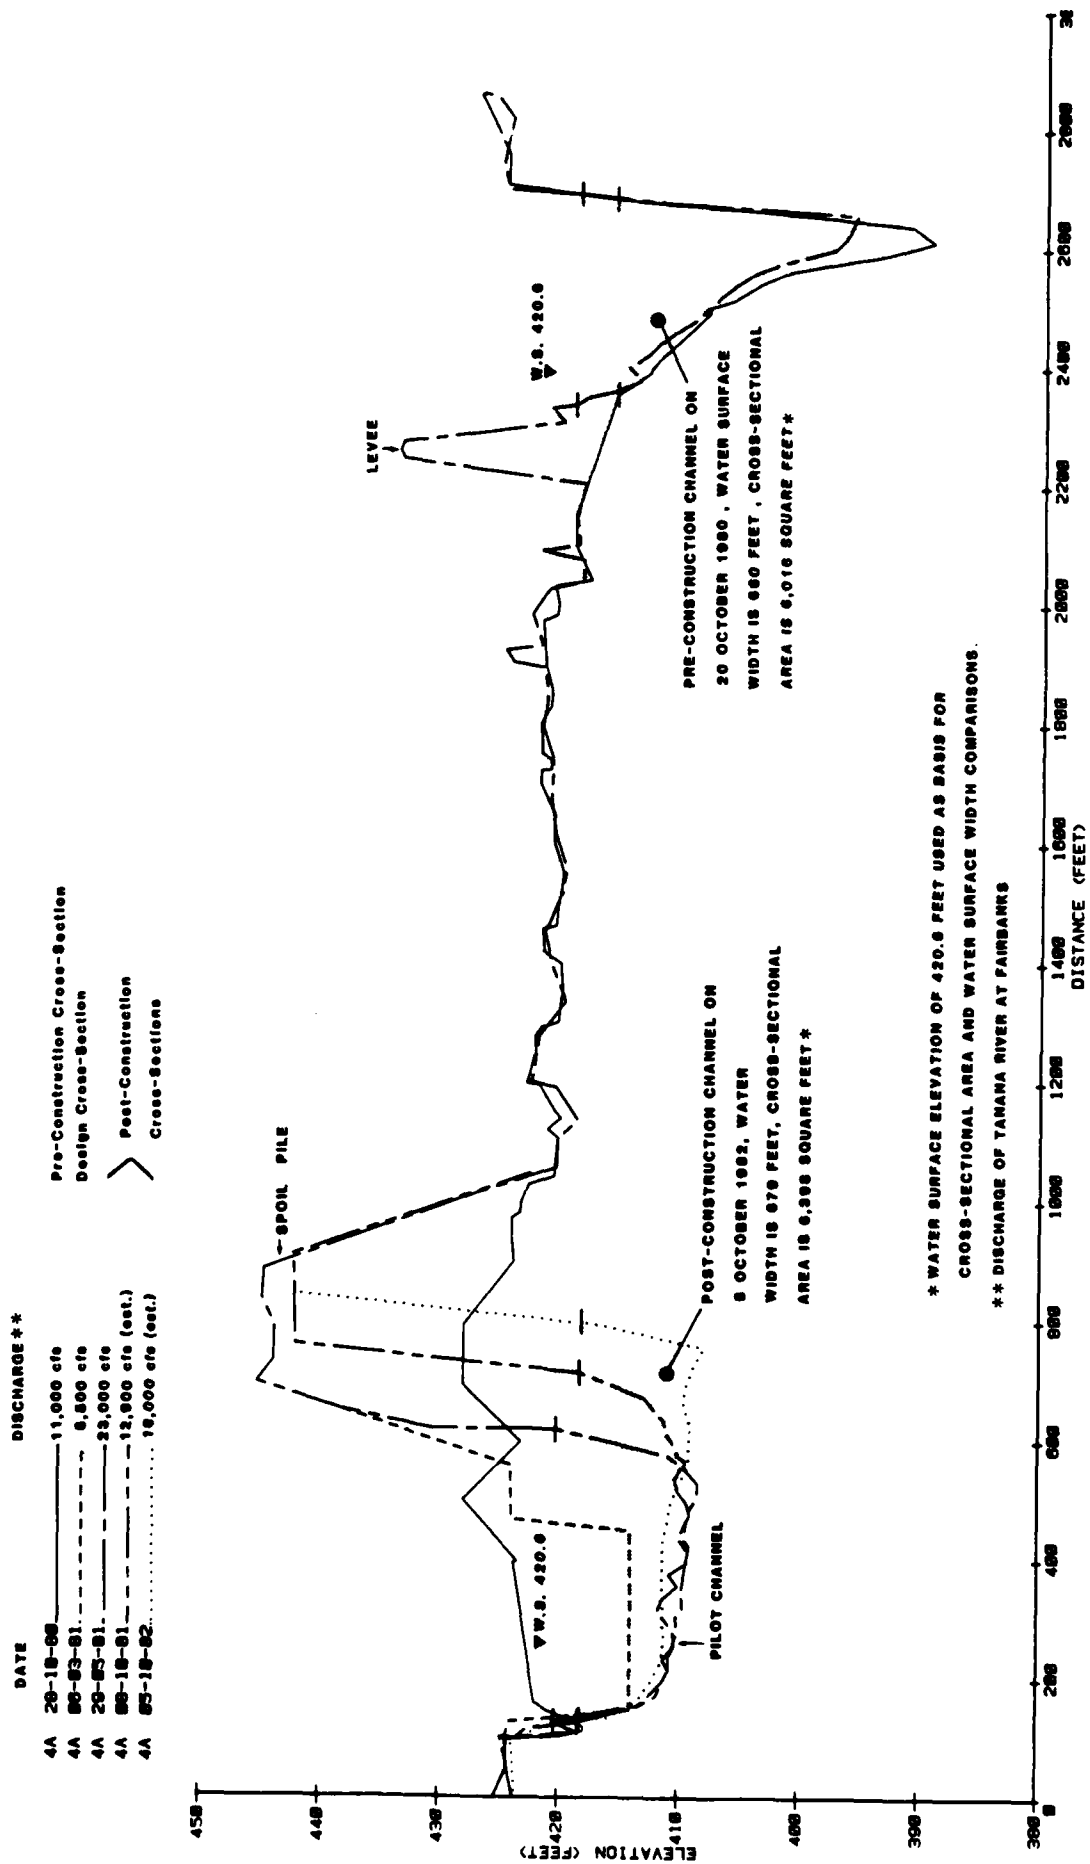
Figure 6.4. Comparison of cross-sectional changes at cross section 4A.

\* A water surface elevation of 420.6 feet was used as a basis for area and water surface width comparisons (see Figure 6.4).

Figures 6.4 and 6.5 show cross-sectional changes at section 4A, which crosses the pilot channel, spoils pile, levee and old river channel in the Phase III area. A numerical comparison of water surface width and cross-sectional area changes is given in Table 6.4. The northward erosion of the pilot channel and spoil pile is clearly evident. The pilot channel has eroded to a water surface width and cross-sectional area which is comparable to the natural pre-construction channel and to other single-channel sections of the river. The pilot channel width has doubled and the cross-sectional area has tripled since the diversion into the channel on 6 March 1981. By 1982, the northward lateral erosion had slowed to about 80 ft per year (Figure 6.4).

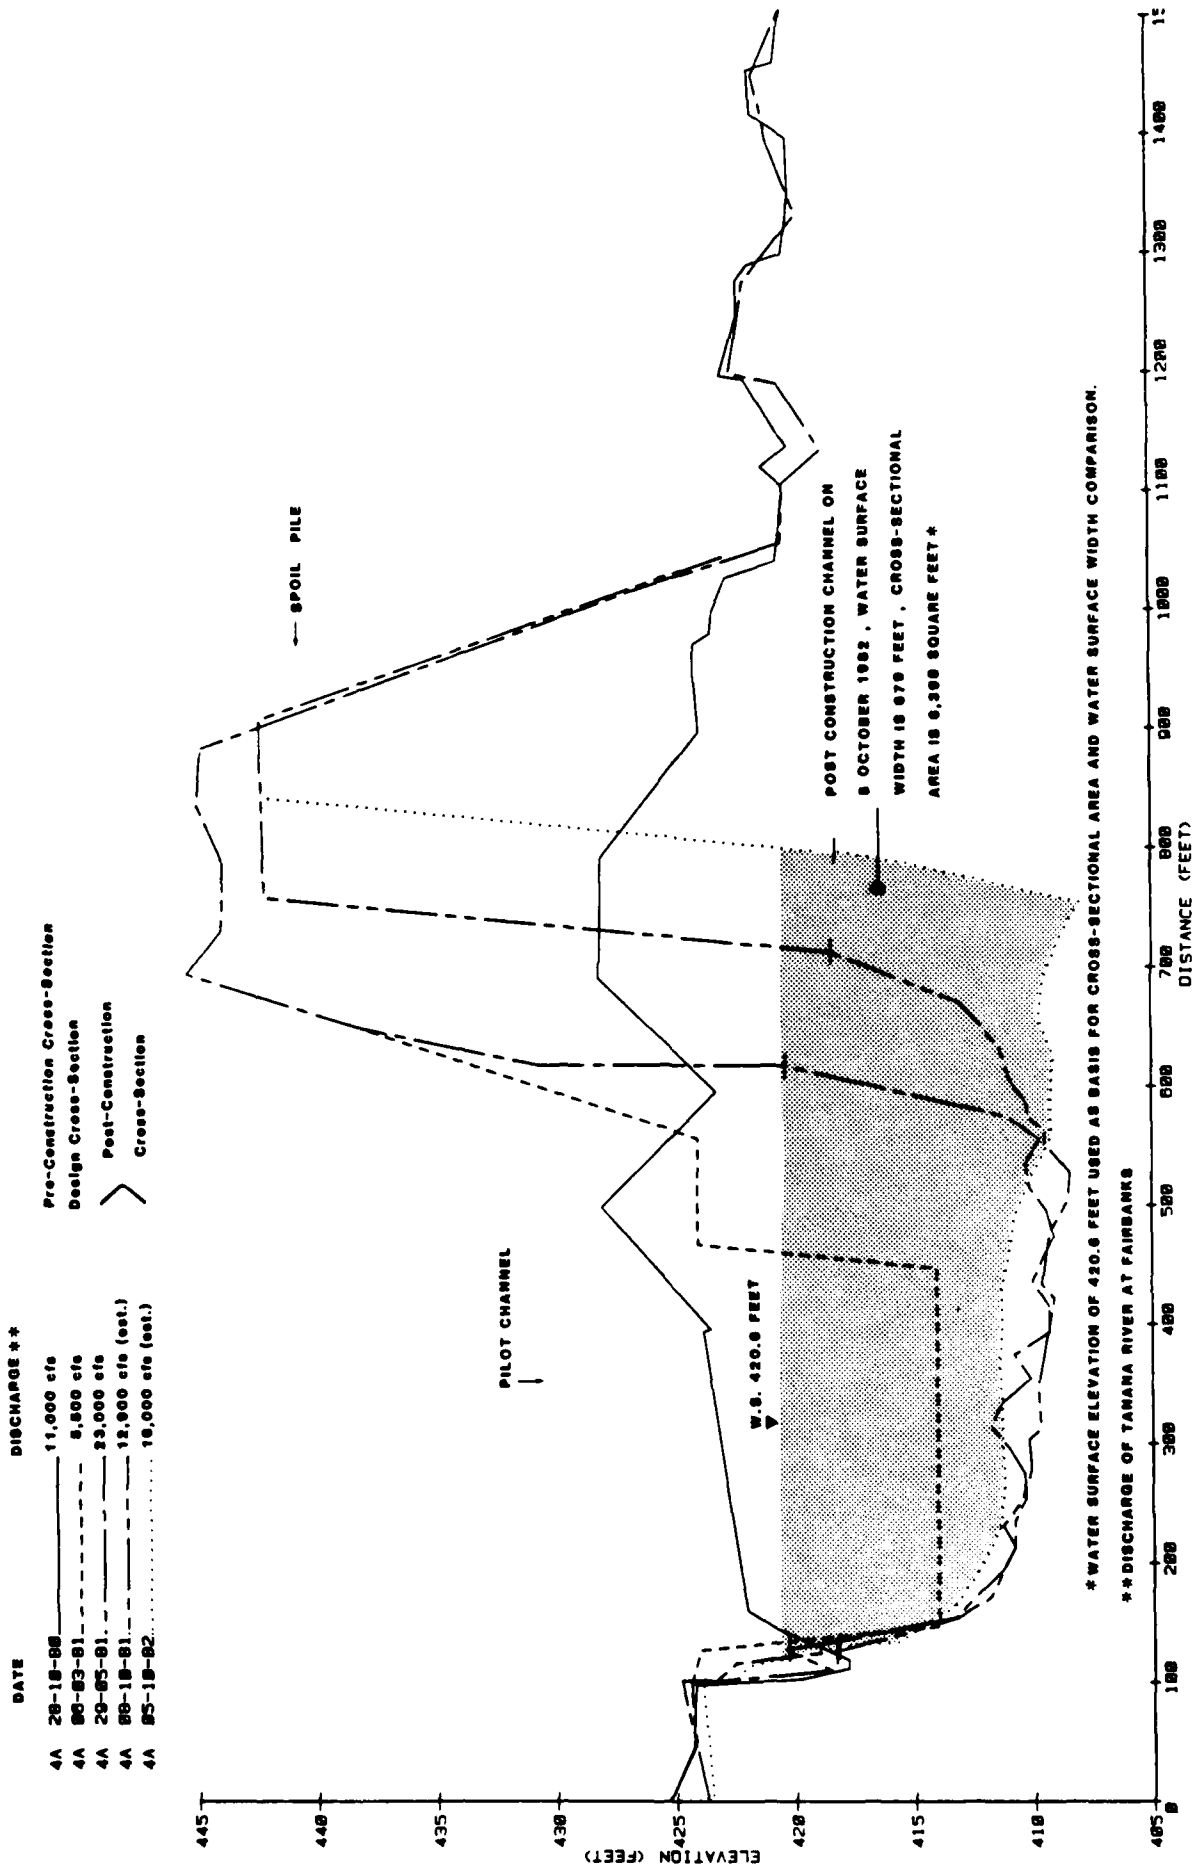
Figure 6.5. Detail of cross-sectional changes at Pilot Channel and spoil pile, cross section 4A.

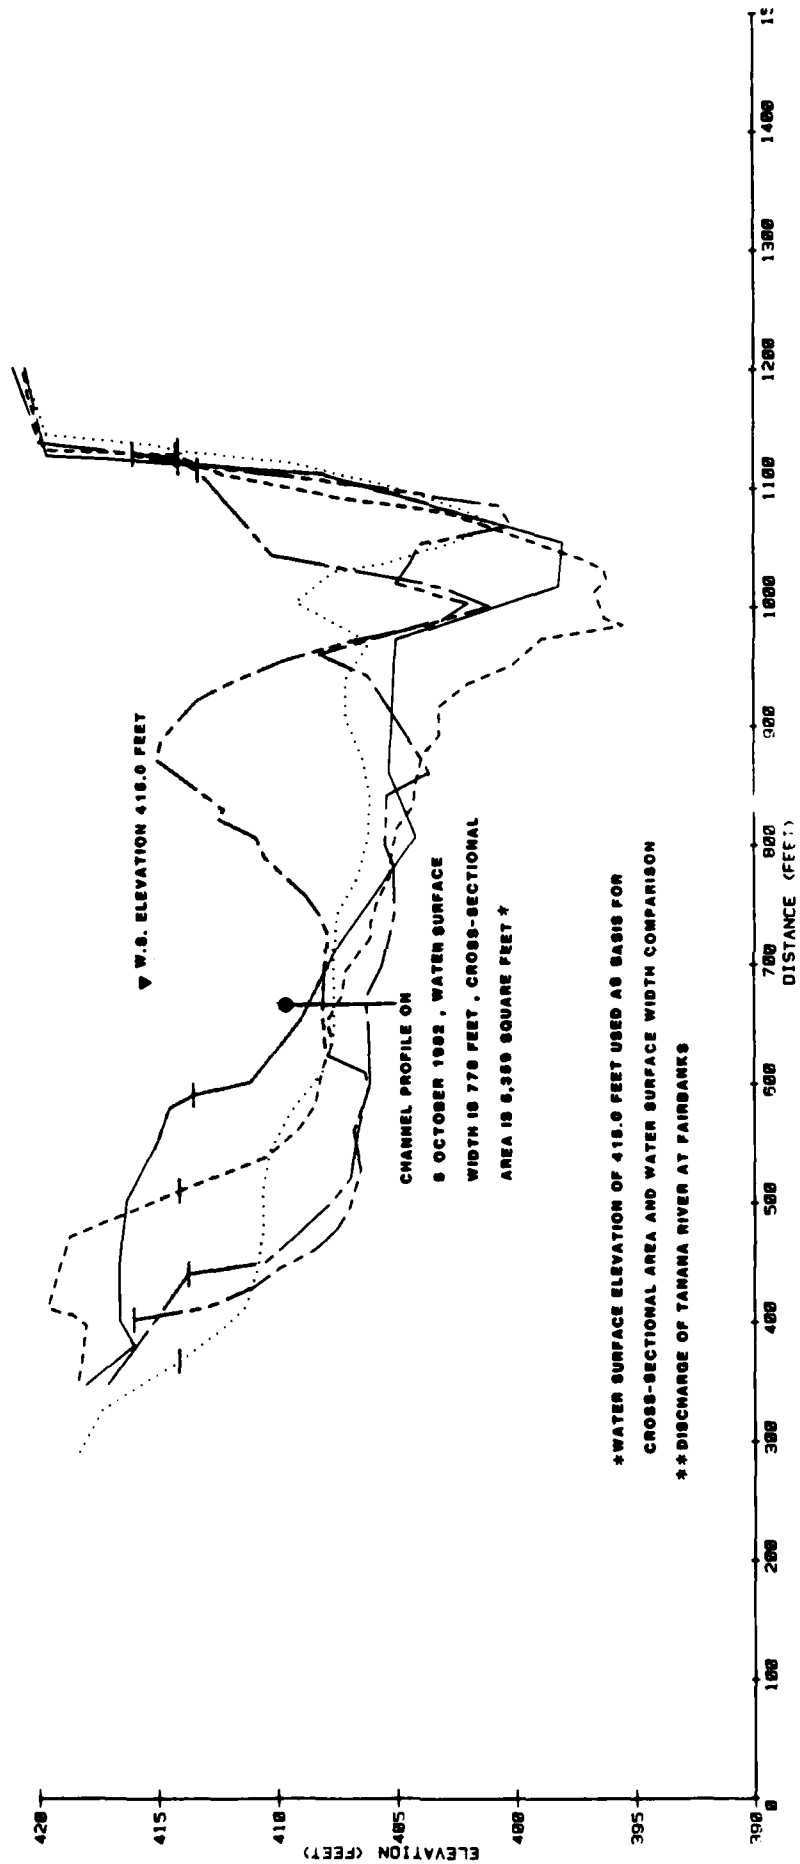
DATE	DISCHARGE **
X4 30-00-70	16,300 cfs
X4 04-10-70	17,200 cfs
X4 20-10-00	13,000 cfs
X4 15-00-01	21,000 cfs
X4 05-10-02	10,000 cfs (est.)

Figure 6.6. Comparison of cross-sectional changes at cross section X4, just downstream of the Chena River confluence.

Figure 6.6 shows cross-sectional changes at section X4, just downstream of the Chena River confluence. Bar development at the mouth of the Chena River is clearly visible in the 15 September 1981 cross section, but is not seen in the 5 October 1982 section\*. Changes at this cross section are summarized in Table 6.5 for the last survey of each open-water season since 1978. The north bank of this cross section has remained relatively stable, but increase in width is occurring by erosion of the south bank, which receded about 150 ft in the period 1978-80 and a further 50 ft since Phase III Construction. The cross-sectional area increased during the high discharge years of 1979 and 1982, and decreased during the relatively low years of 1980 and 1981. During the period immediately following Phase III Construction (20 October 1980 to 15 September 1981), the cross-sectional area decreased by 17%, due to deposition of the bar shown in the 15 October 1981 cross section. The bar was closely monitored during the 1982 open-water season. Table 6.6 shows data from surveys conducted during 1981 and 1982 at cross section X4, and gives the location of the bar high point (refer to Figure 6.6) and the minimum water

\* Evidence of the nucleus of this bar can be seen in cross sections from 1979, pre-dating Phase III Construction: see Figure 6.6 for example.

\* A water surface elevation of 415.0 feet was used as a basis for area and water surface width comparisons (see Figure 6.6).

NOTE: The right bank station varies with water surface elevation between station 1140 and 1145 feet (see Figure 6.6).

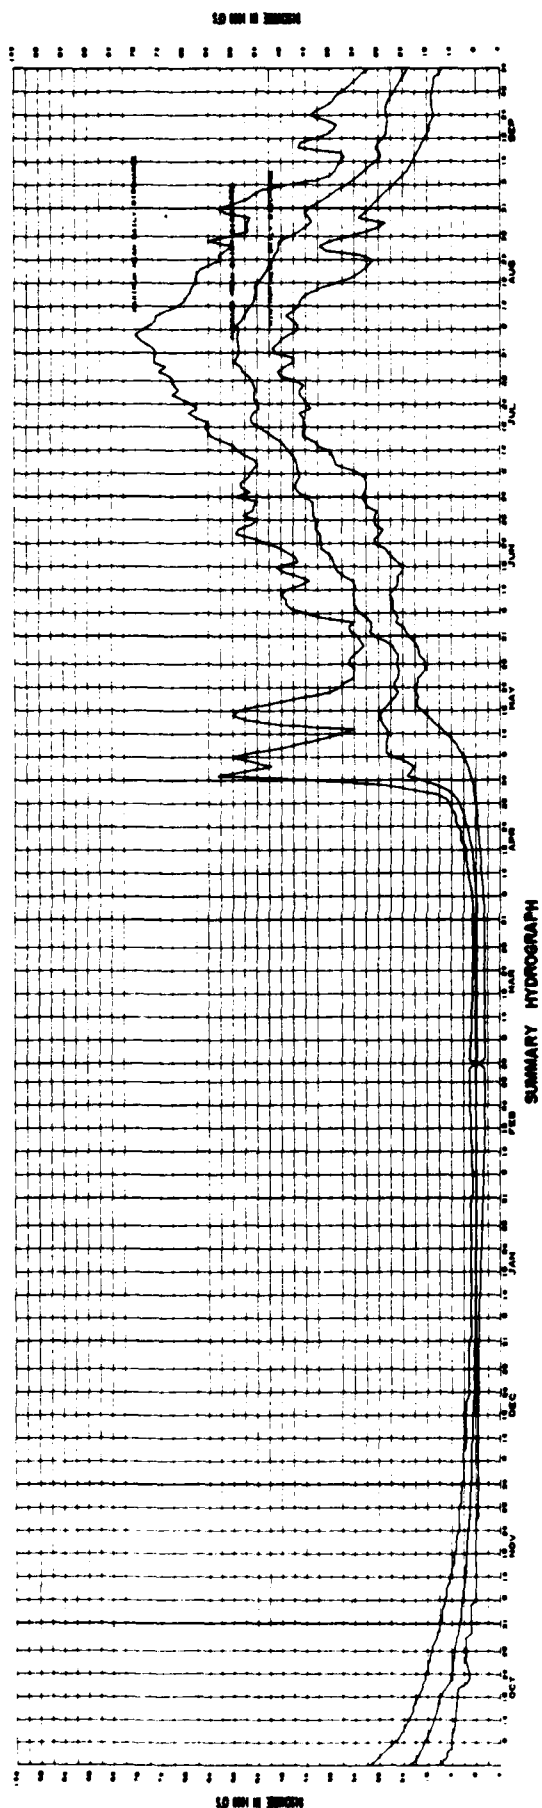
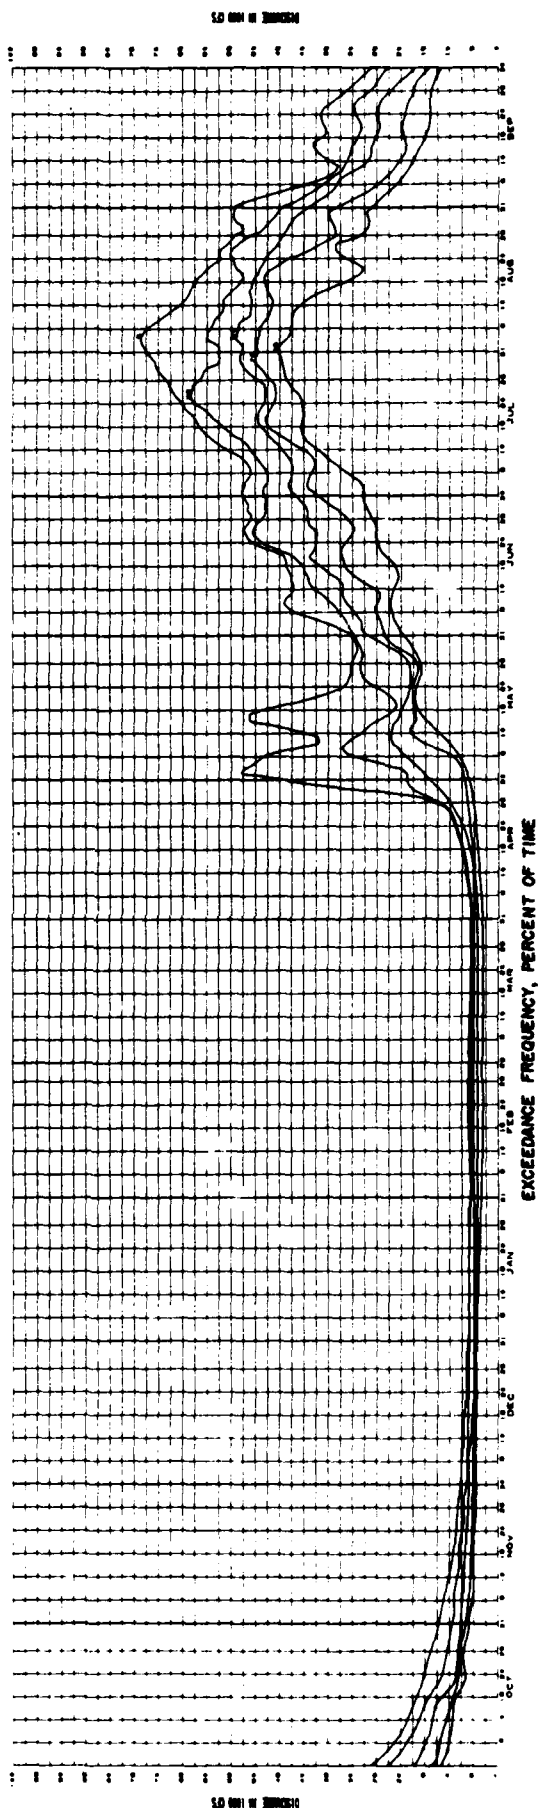
# TANANA RIVER AT FAIRBANKS

Figure 2. Summary hydrograph and exceedance frequency curves.

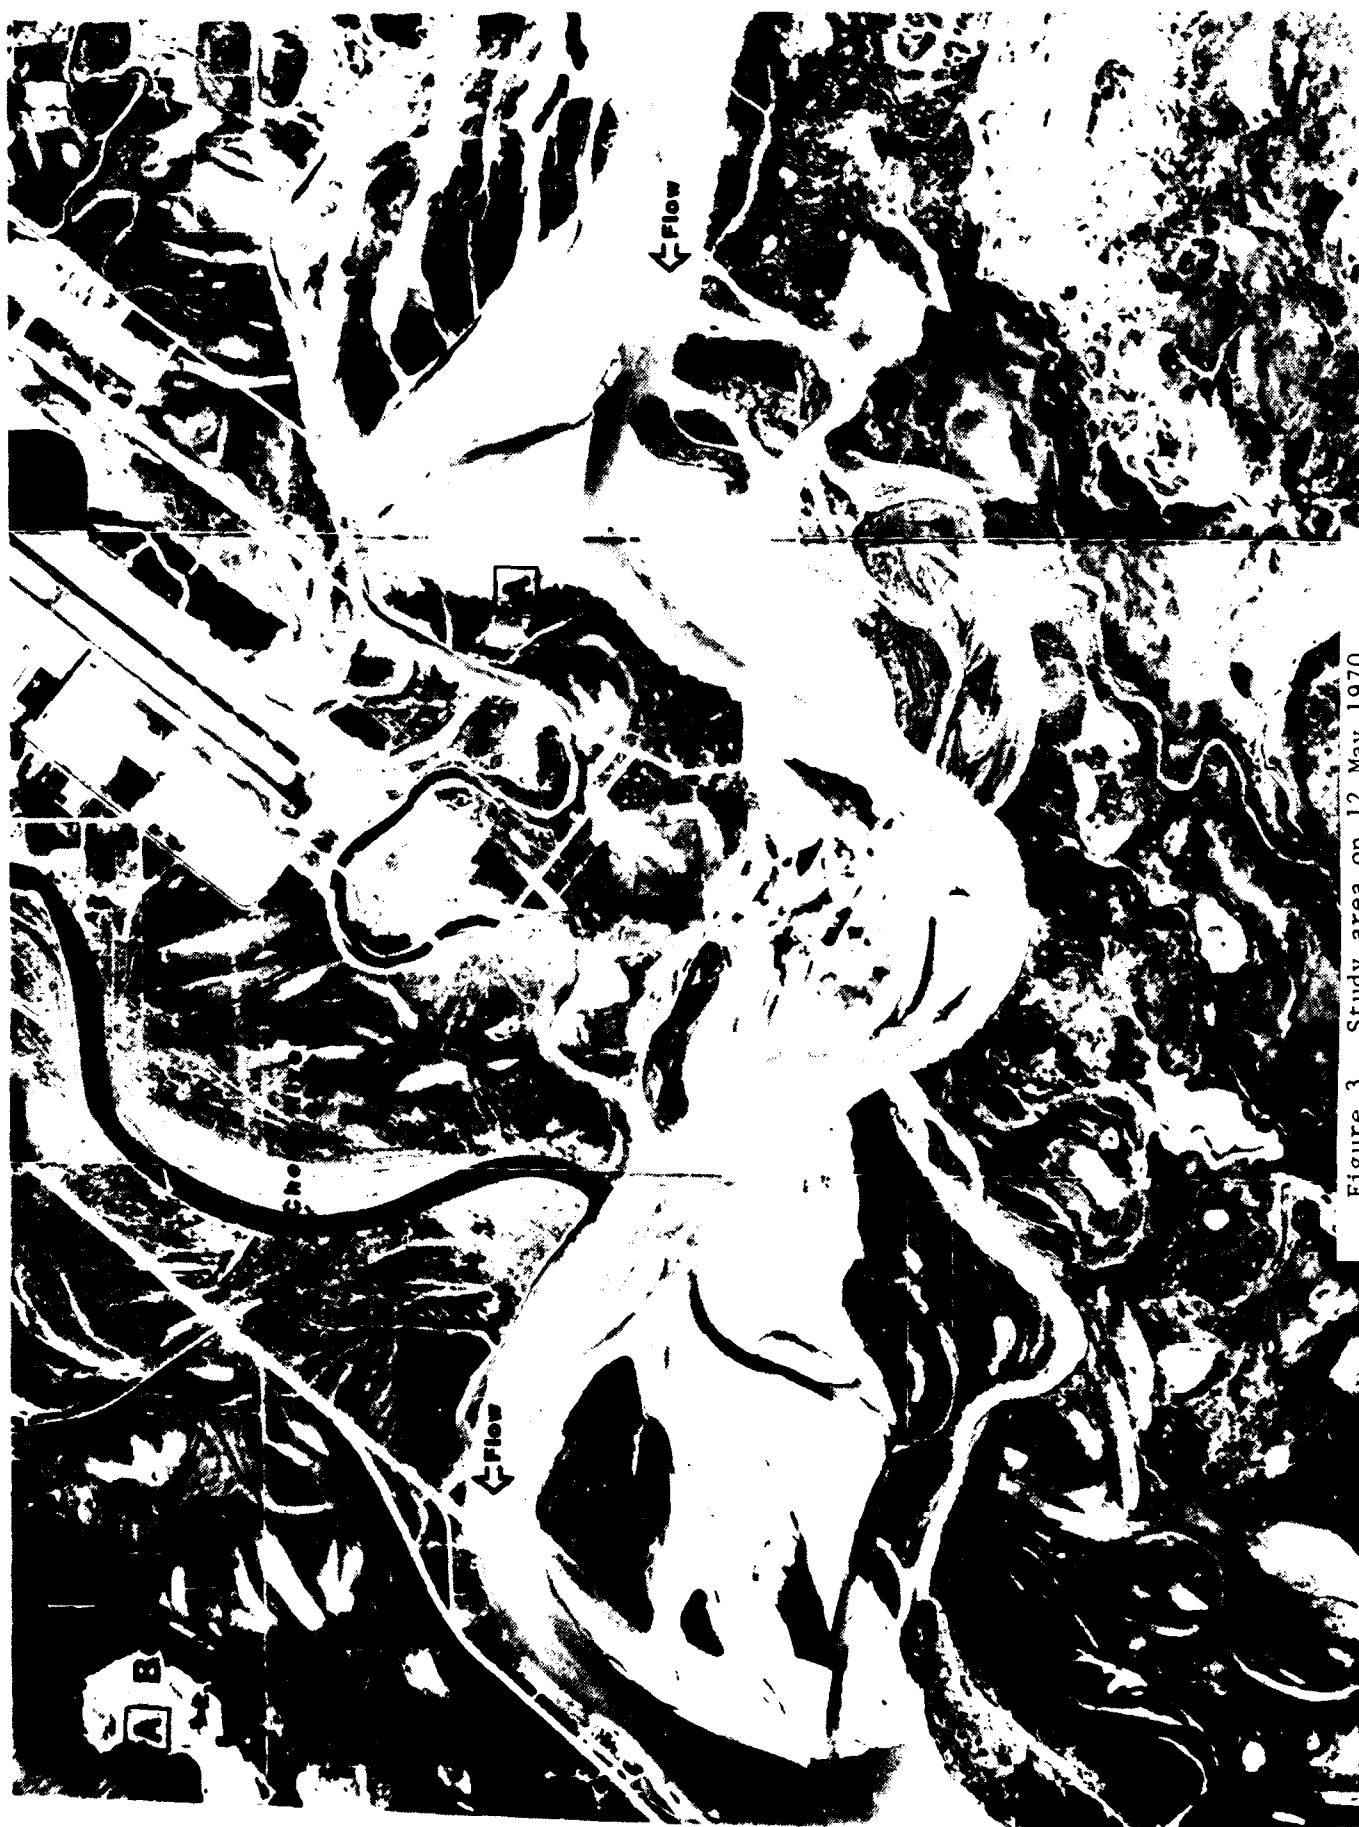
Figure 3. Study area on 12 May 1970.

The overall area of interest (Fig. 1) was studied for changes in riverbank, sandbar and channel locations, while only riverbank erosion on the outside of the Bends A, B and C was measured. Figures 3 and 4 show the overall study area prior to the Phase III construction on 12 May 1970 and 7 May 1980, respectively. Figures 5 and 6 show the area after the Phase III construction on 29 May 1981 and 20 October 1981, respectively. Figures 7 through 9 are oblique views, looking upstream, of the Phase III construction area on 20 June 1980, 23 June 1981 and 6 August 1981 respectively.

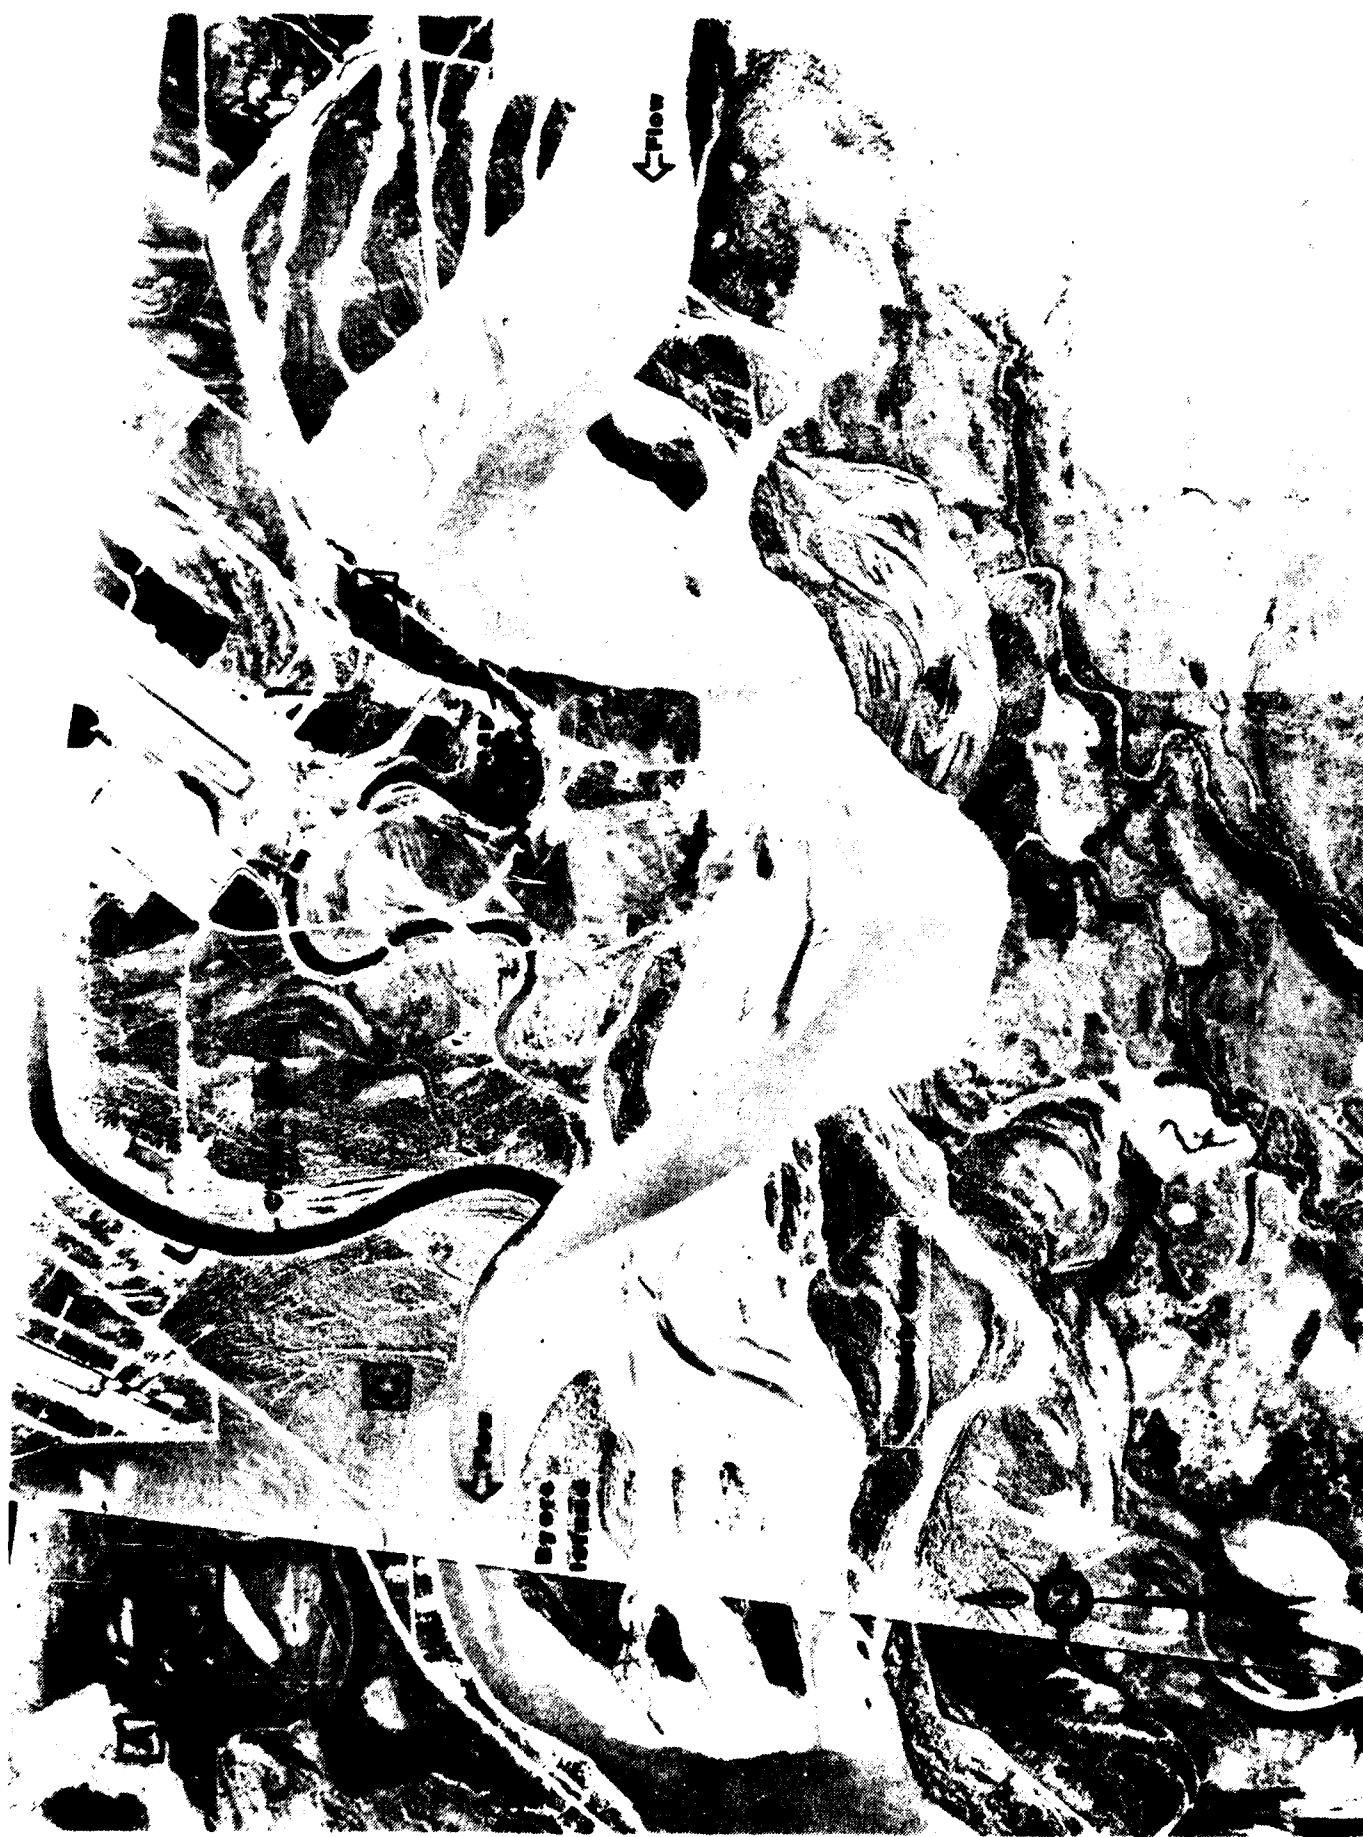
Figure 4. Study area on 7 May 1980.

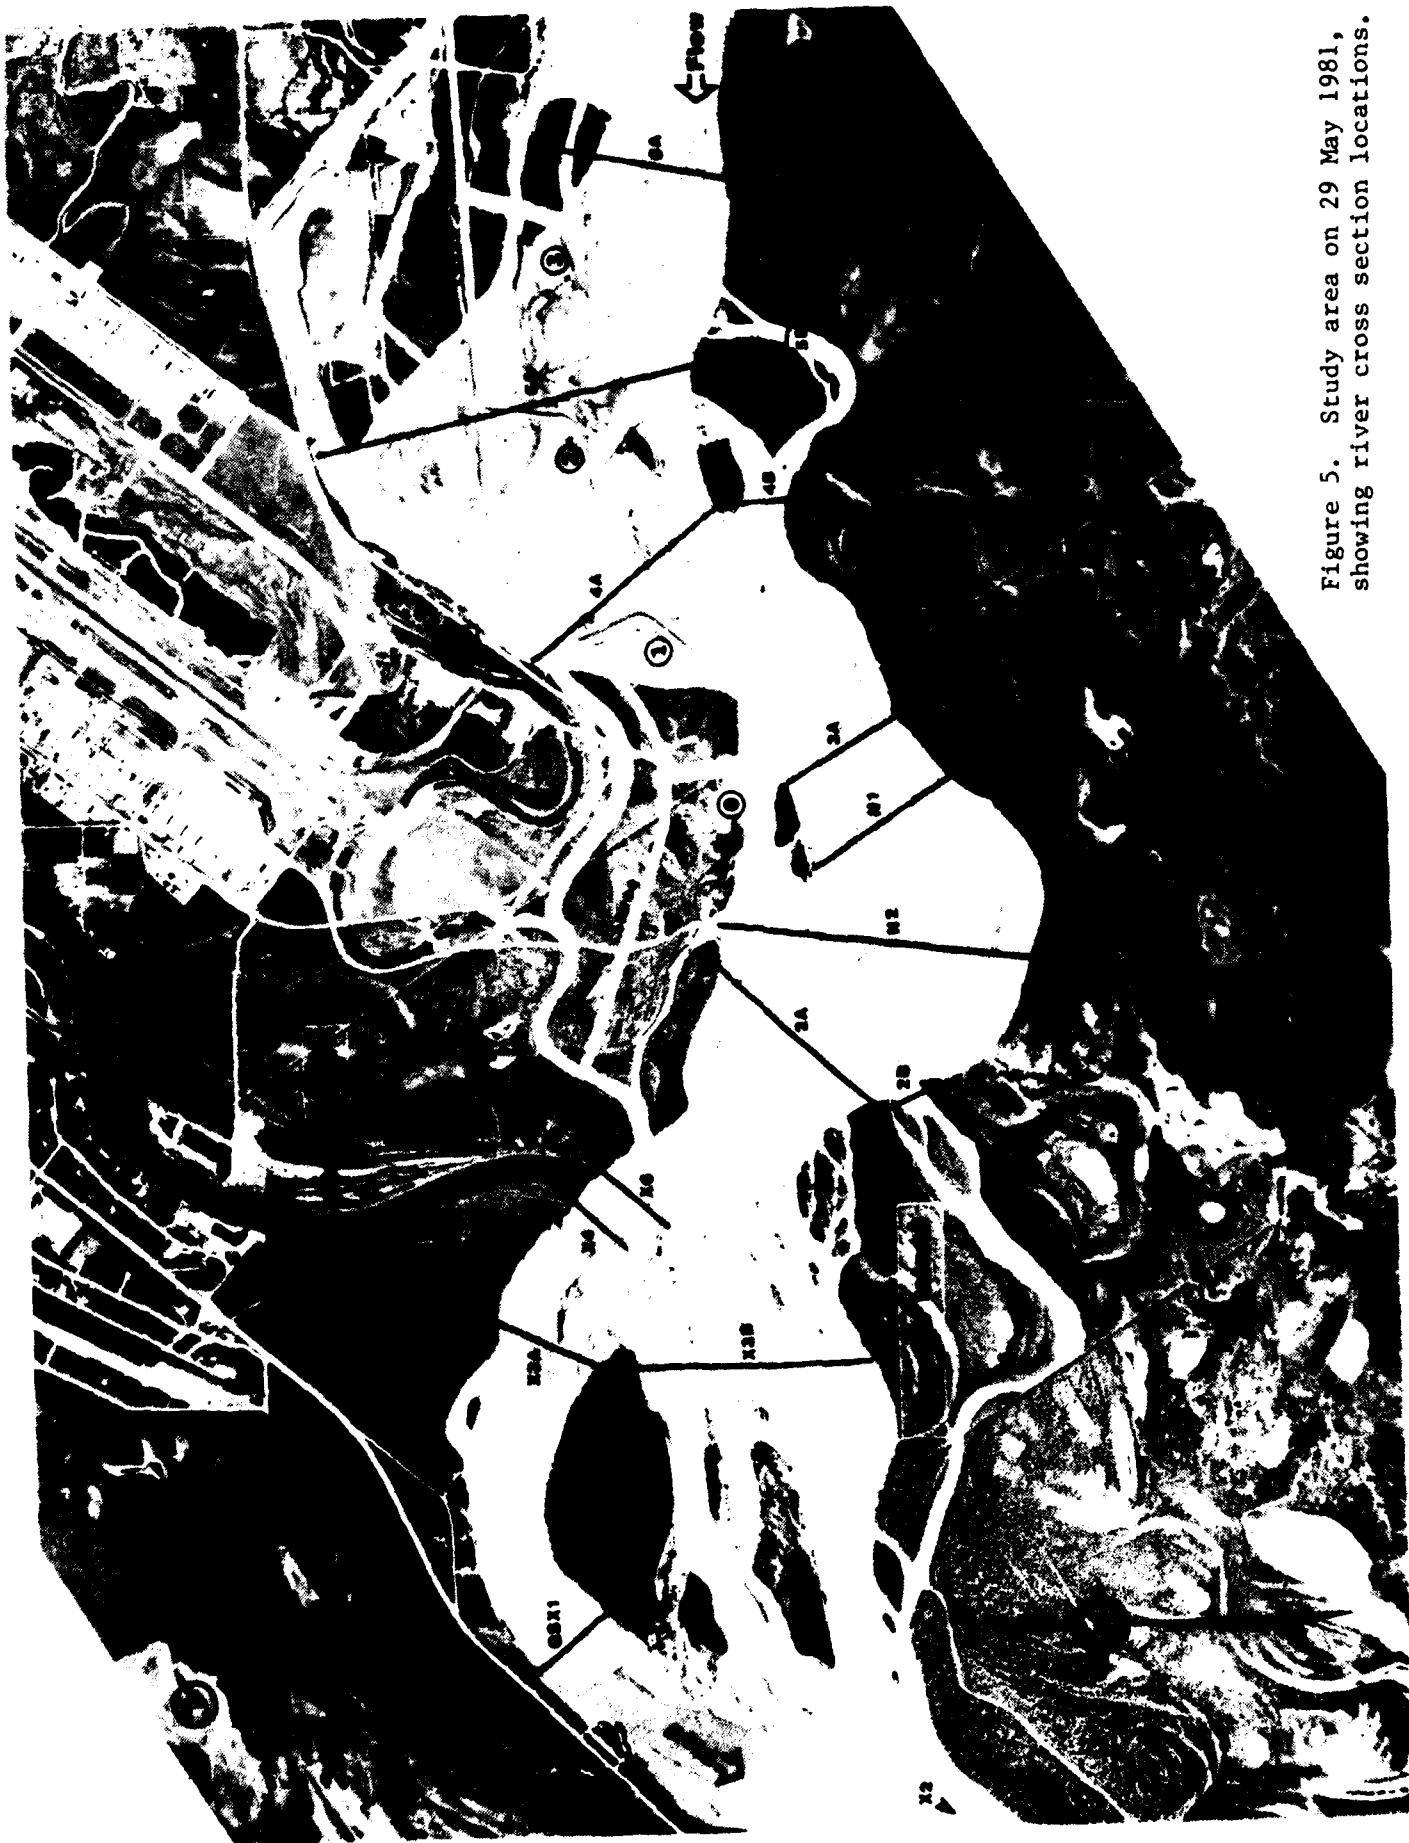
Figure 5. Study area on 29 May 1981, showing river cross section locations.

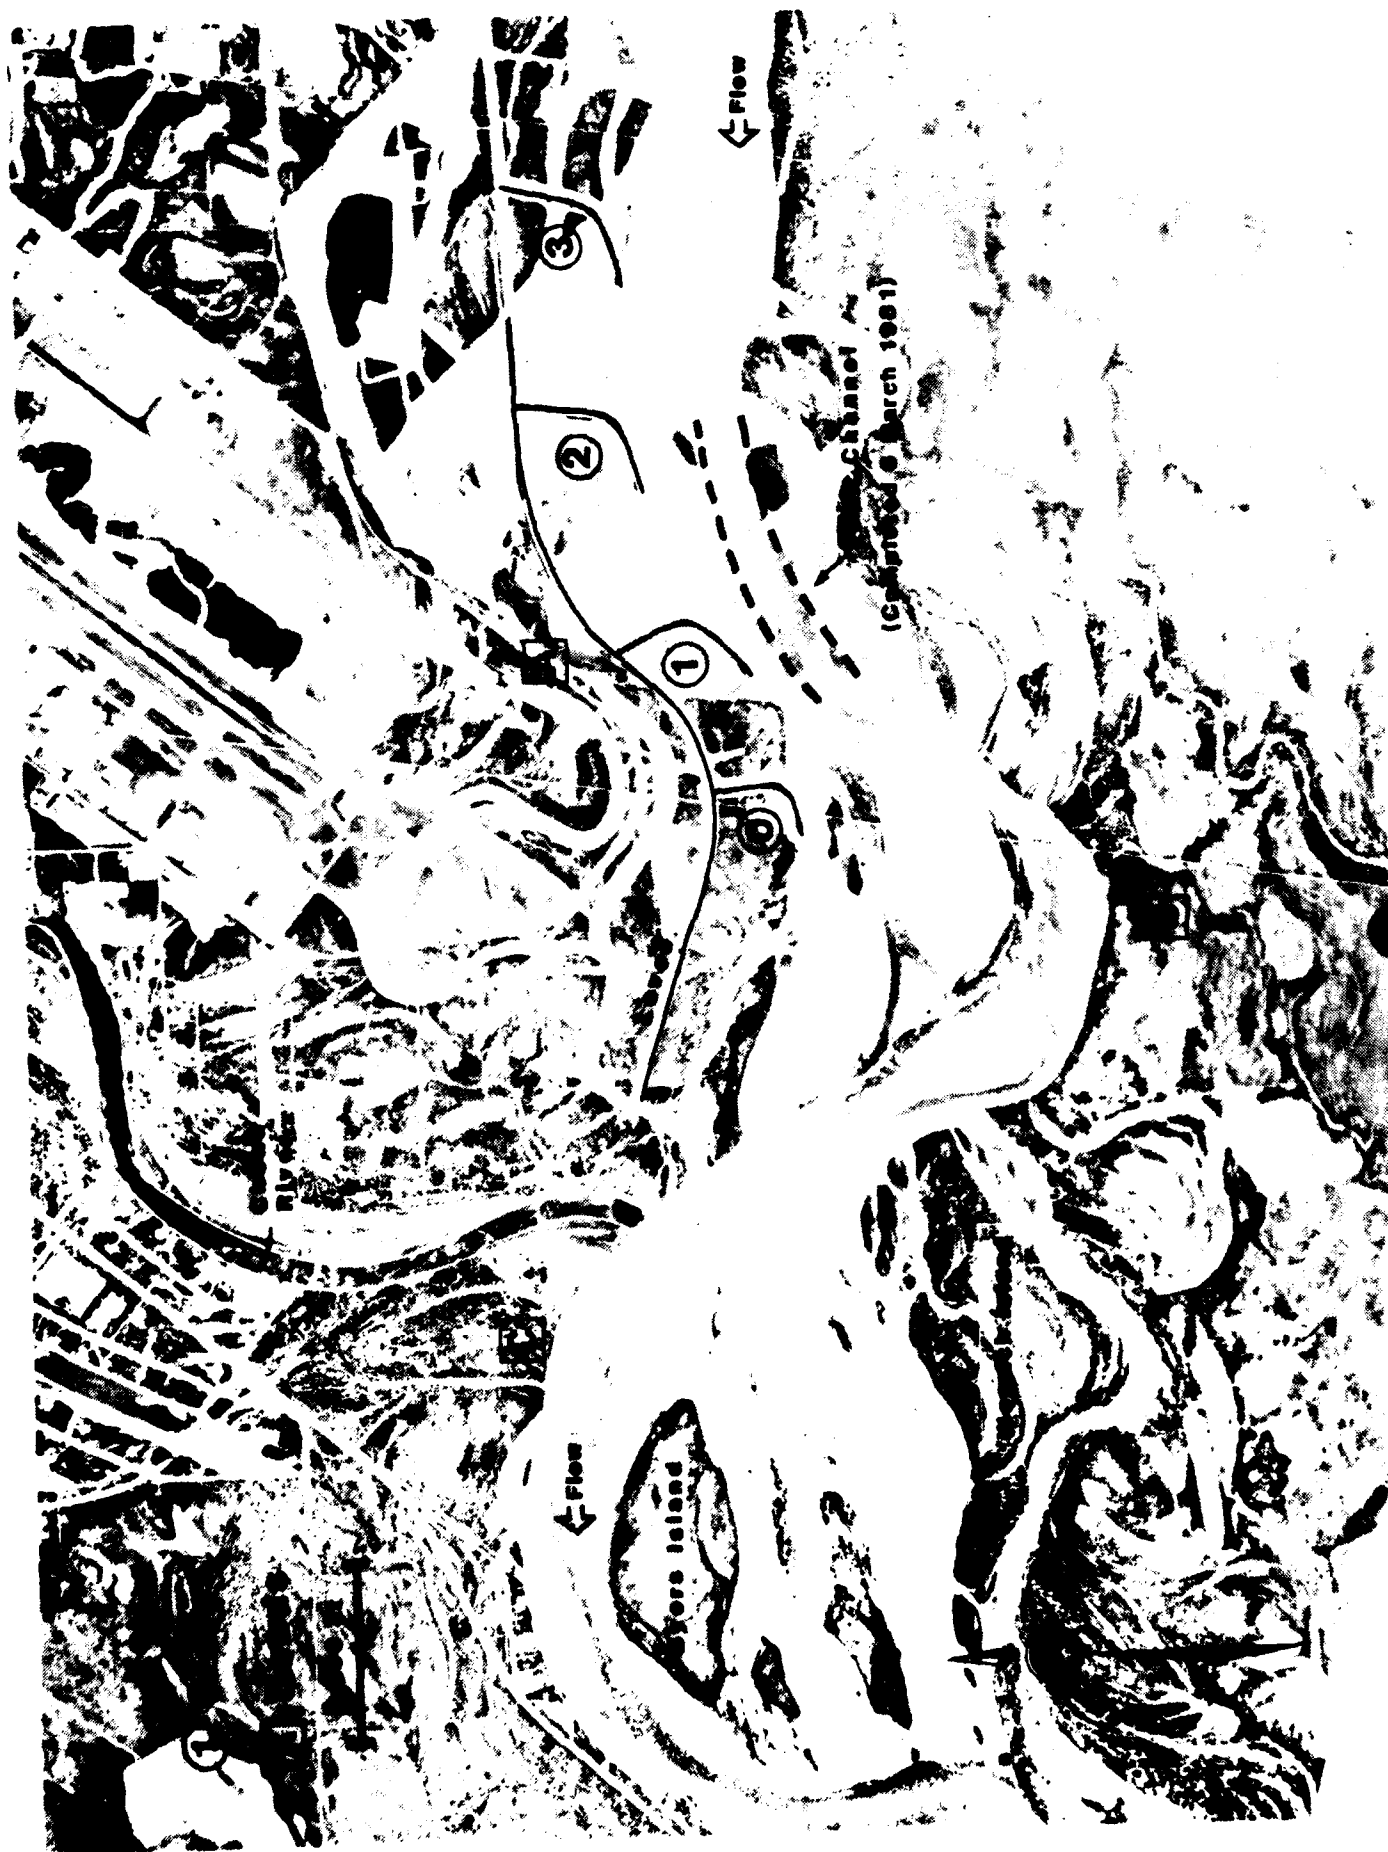
Figure 6. Study area on 20 October 1981.

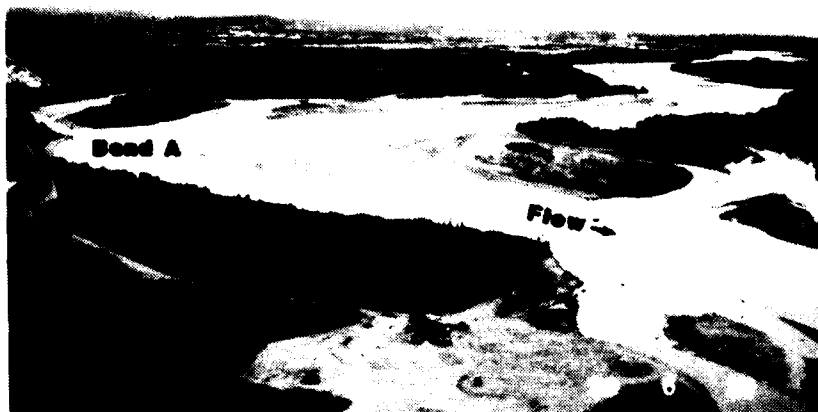
Figure 7. Phase III construction area on 20 June 1980.

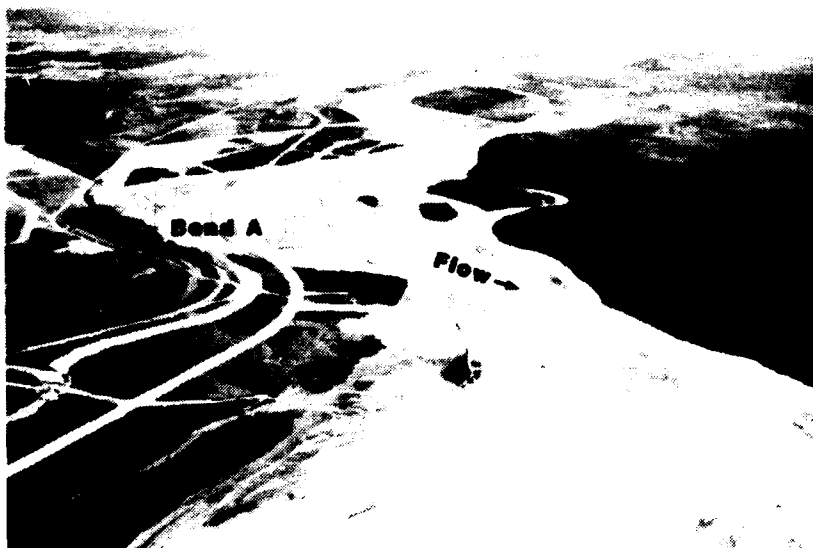
Figure 8. Phase III construction area on 23 June 1981.

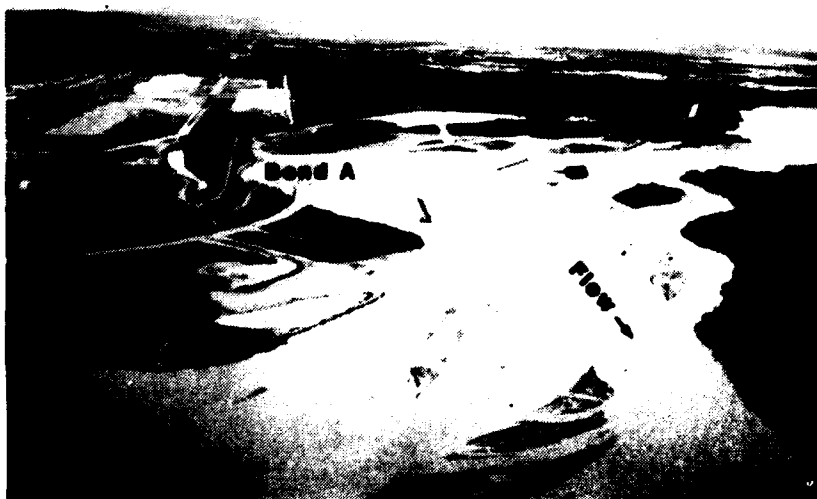
Figure 9. Phase III construction area on 6 August 1981.

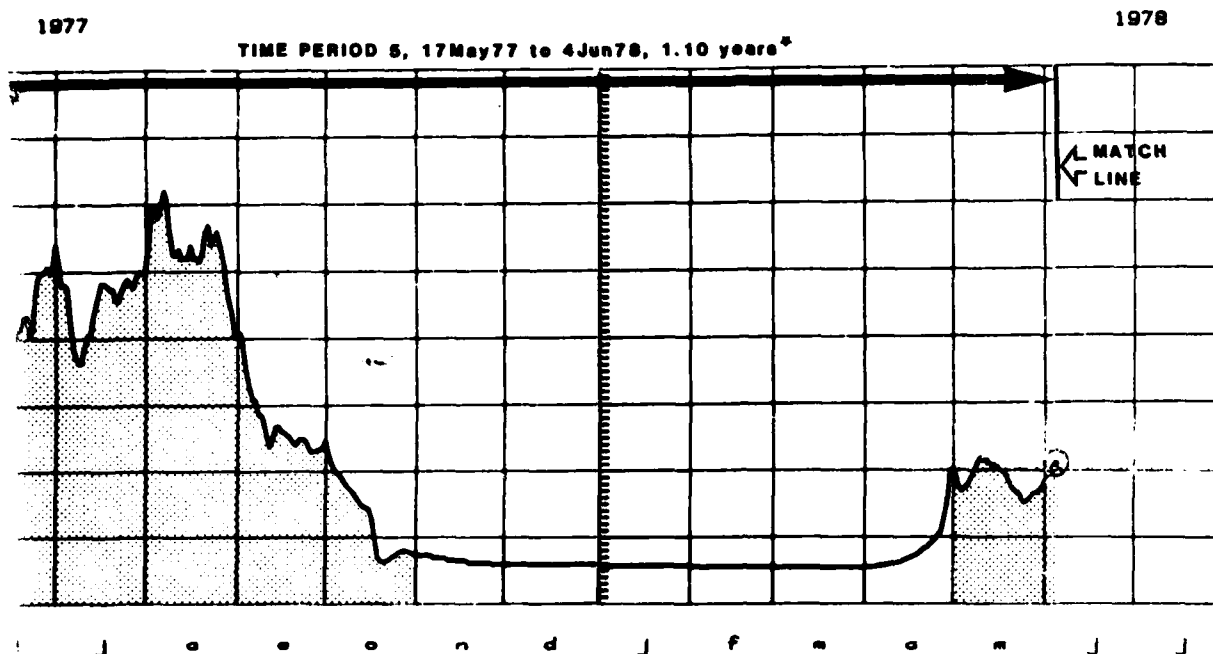
## FIGURE 10

DATES OF AERIAL PHOTOGRAPHY AND  
TIME PERIODS WITH RESPECT TO THE  
TANANA RIVER DISCHARGE, 1973 TO 1981

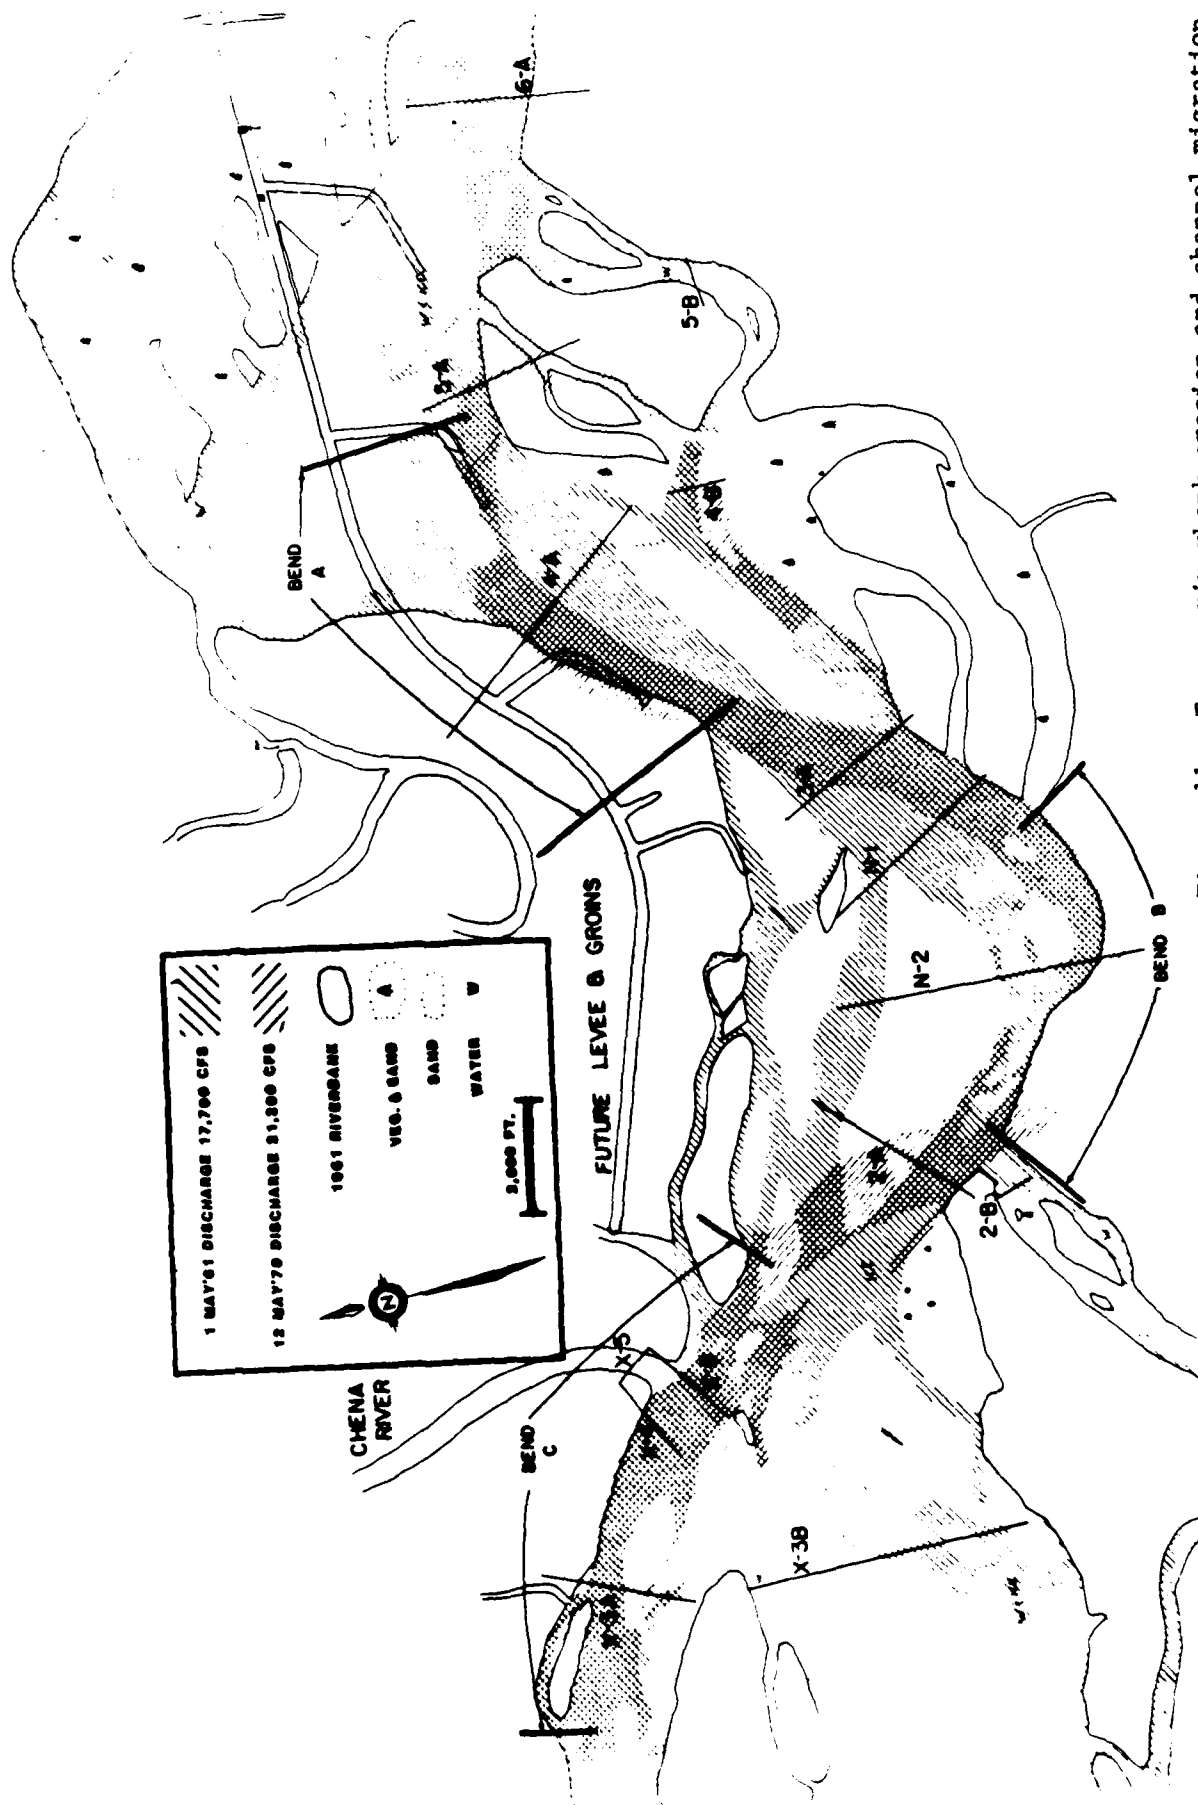
Figure 11. Tanana riverbank erosion and channel migration from 29 May 1981 to 20 October 1981.
